Zamfara, Nigeria Lead Poisoning Epidemic Emergency Environmental Response

FINAL REPORT

TerraGraphics Environmental Engineering, Inc.

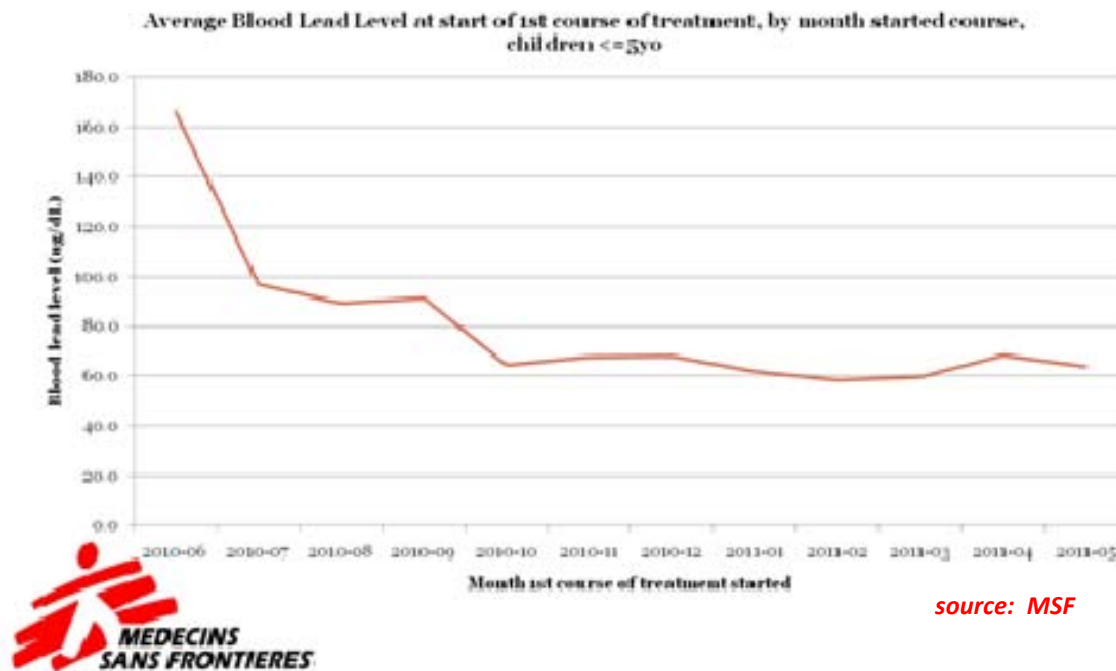
Figure 1. Blood lead levels of children starting chelation treatment for lead poisoning.

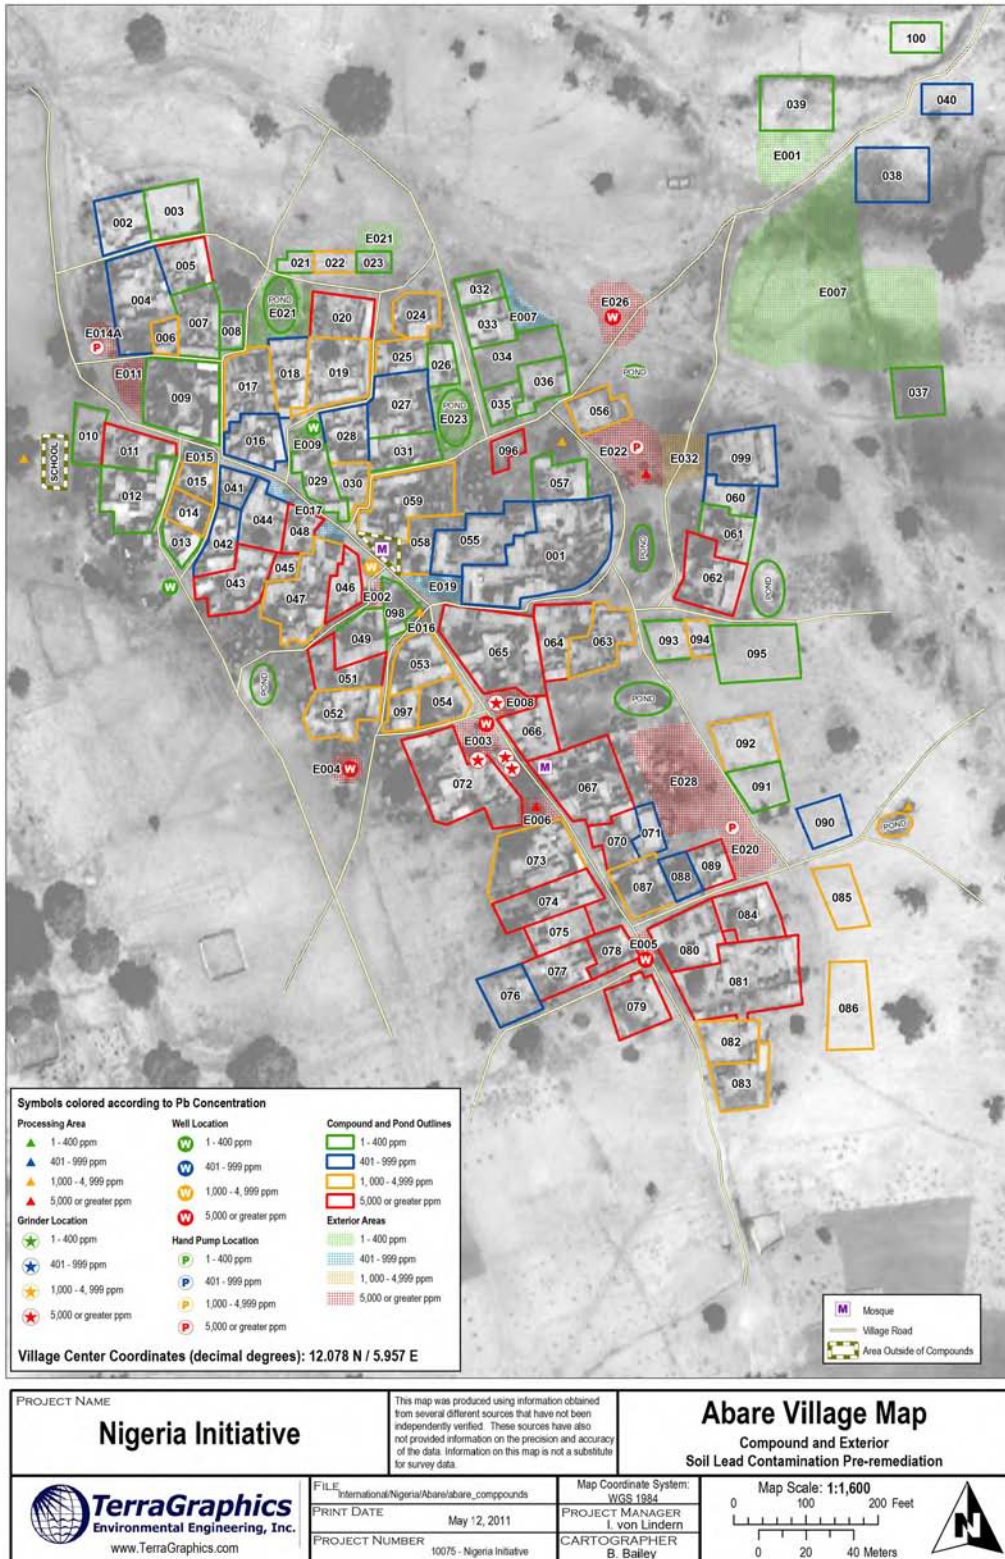
Figure 3. Pre remediation contamination levels in compounds and public areas in Abare.

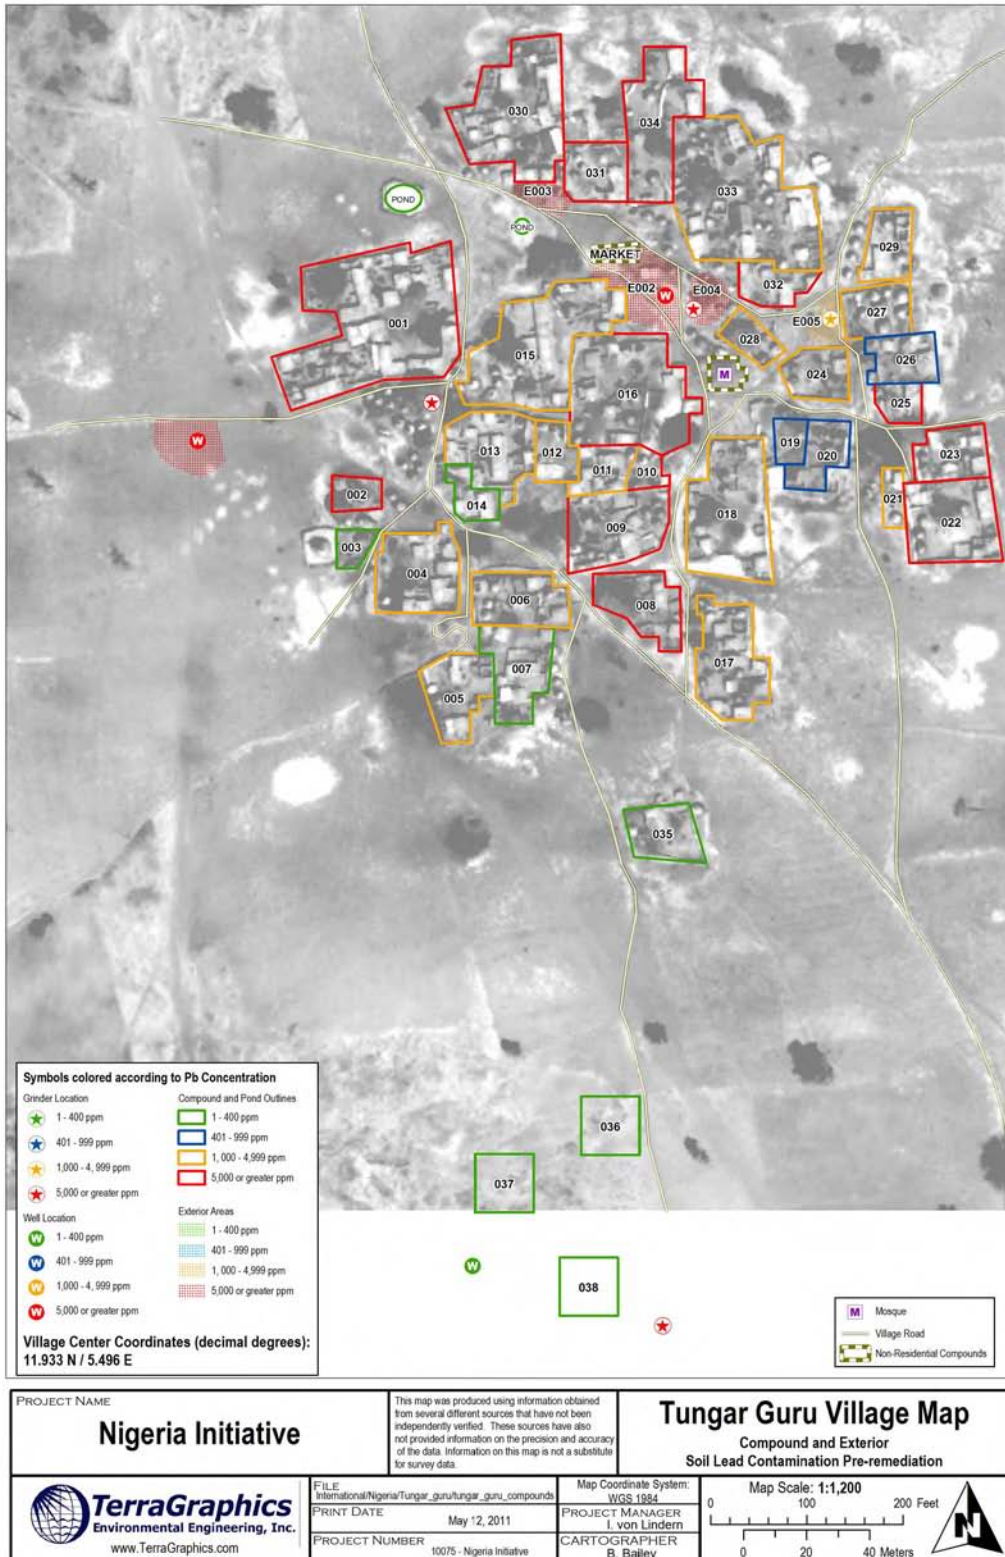
Figure 4. Pre remediation contamination levels in compounds and public areas in Tungar Guru.

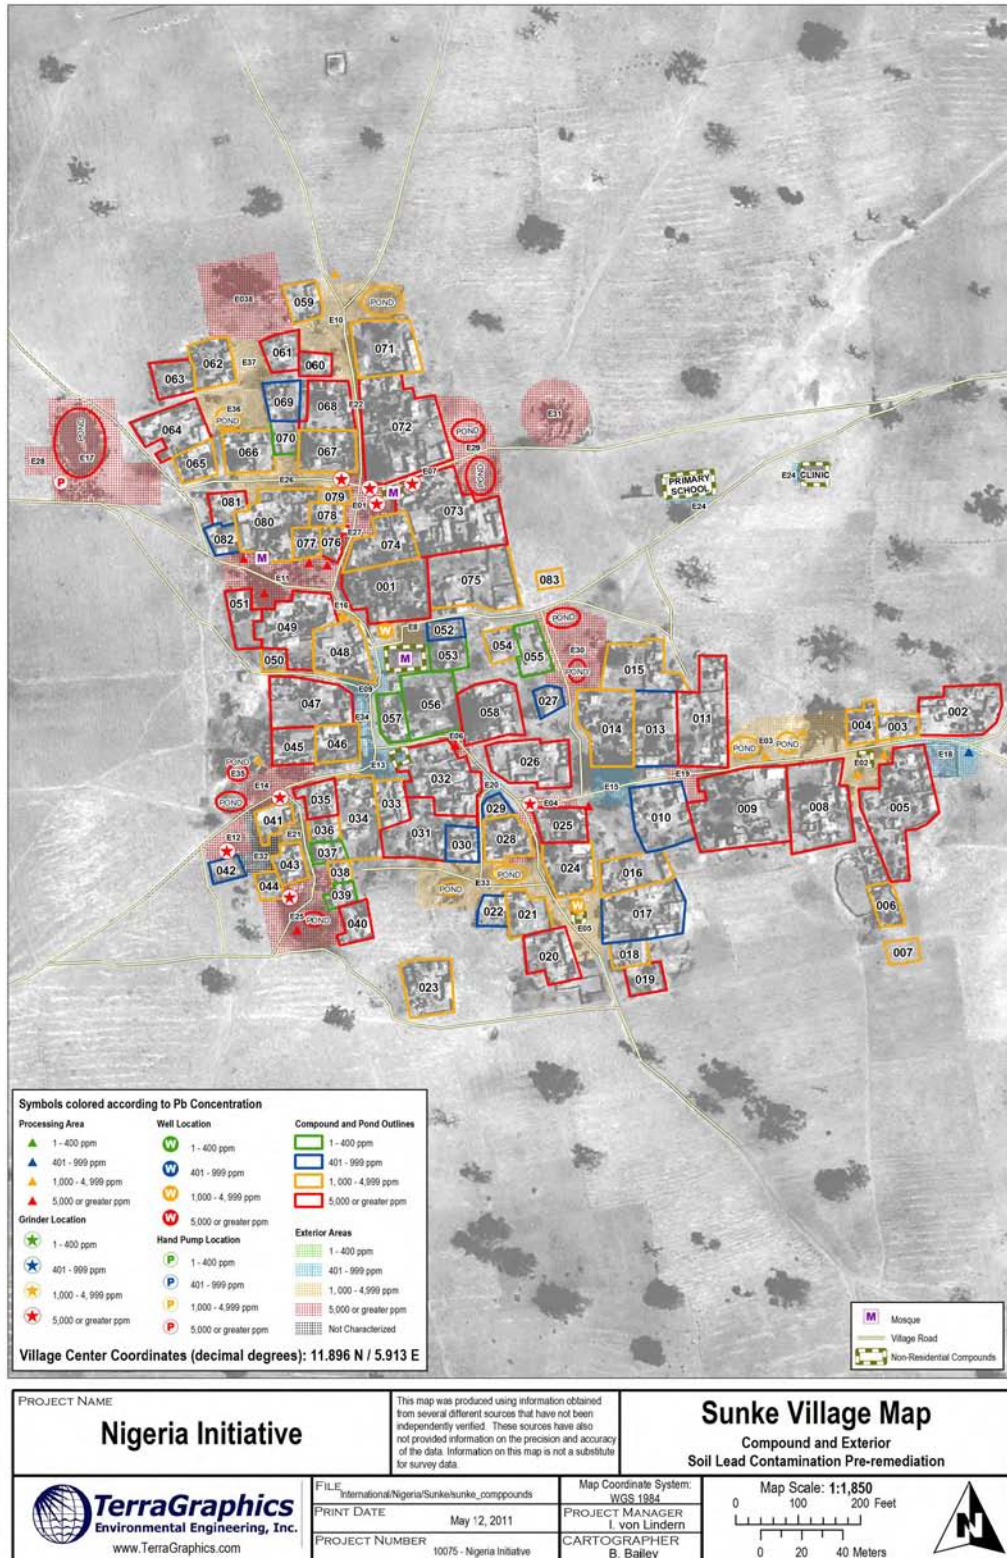
Figure 5. Pre remediation contamination levels in compounds and public areas in Sunke.

Metal concentrations in Sunke pond mud ranged from 800 to >30,000 mg/kg lead and up to 2000 mg/kg mercury, with the majority of readings in the 1000–5000 mg/kg lead range. In Daret, pond mud contaminant concentrations ranged from 1000 to 70,000 mg/kg lead and up to 125 mg/kg mercury. Bricks made from the pond mud had contaminant concentrations ranging from 1000 to 40,000 mg/kg lead and up to 100 mg/kg mercury. Similar levels were noted in Tungal Daji and Yarlama.

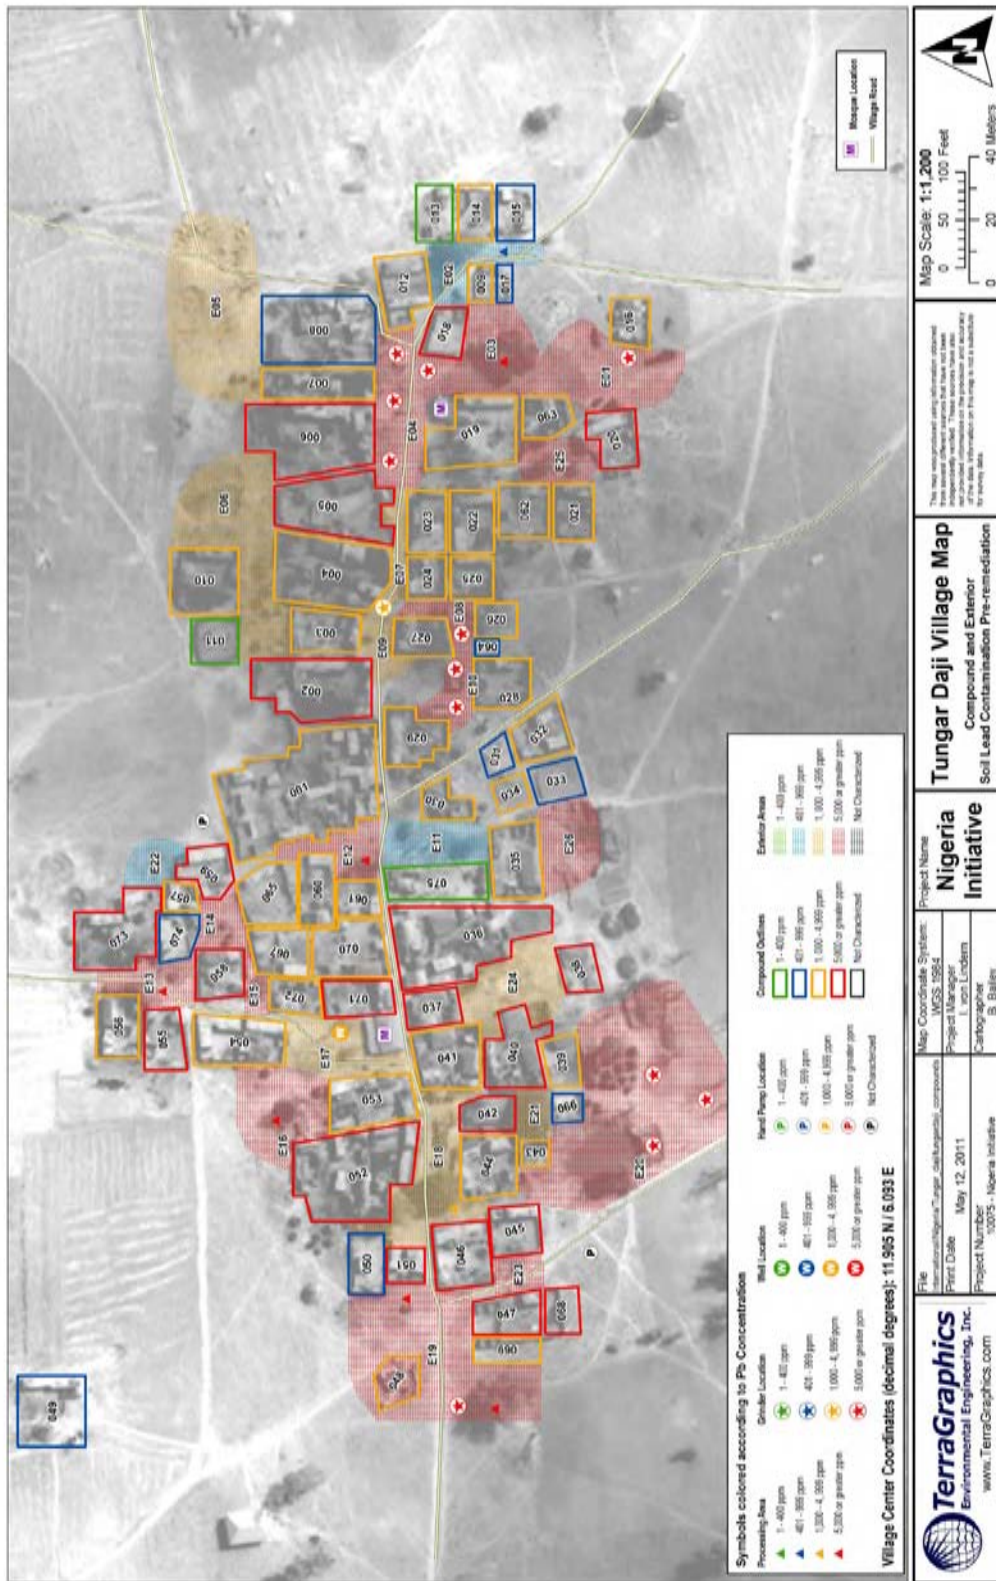
Figure 6. Pre remediation contamination levels in compounds and public areas in Tungar Daji.

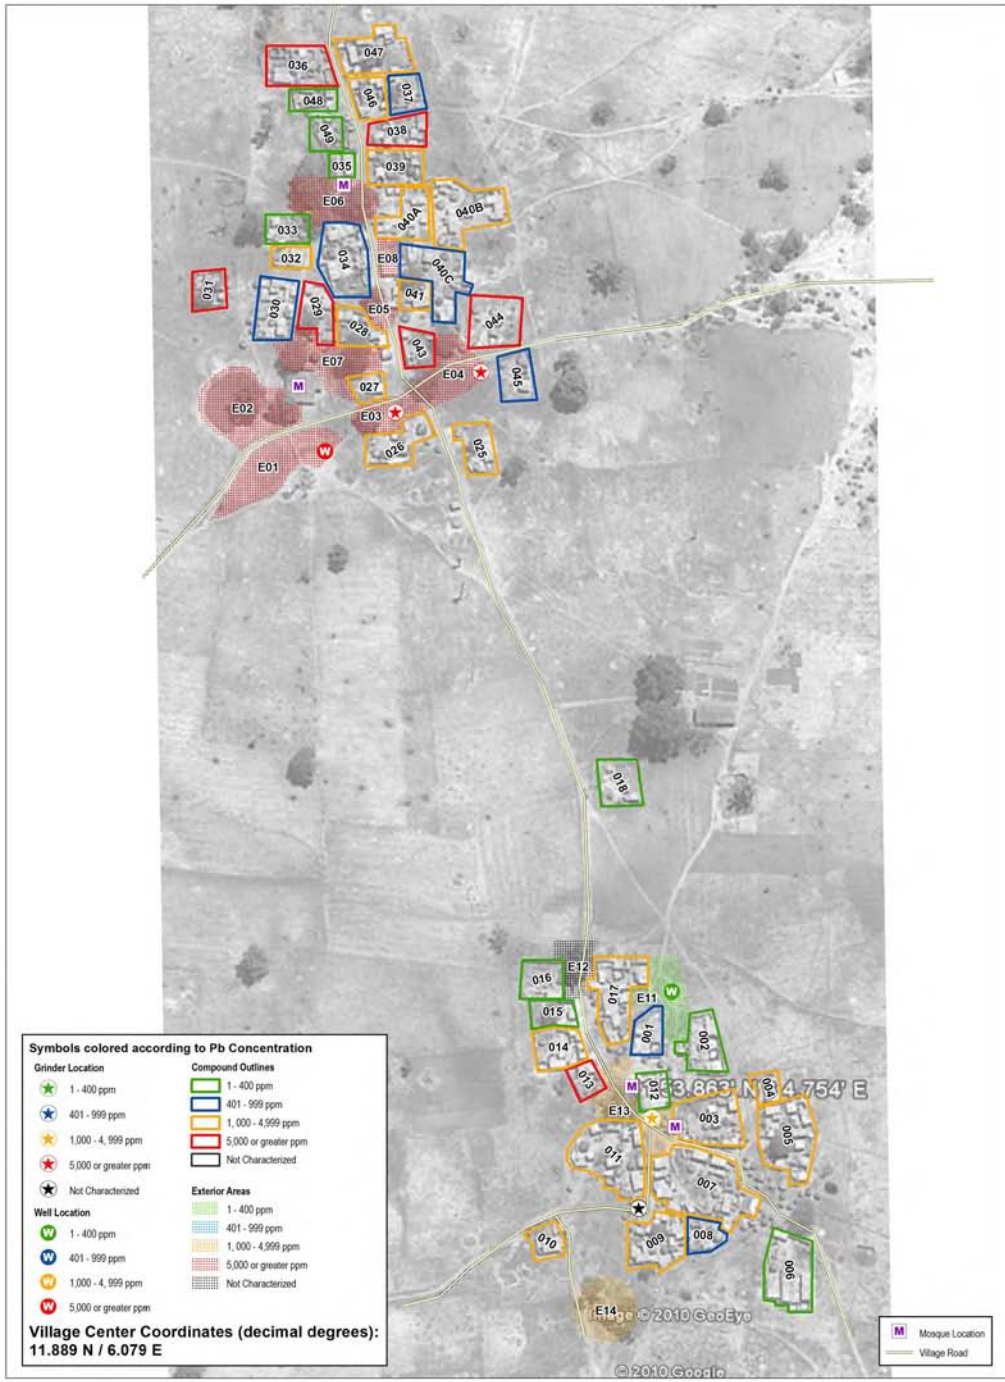
Figure 7. Pre remediation contamination levels in compounds and public areas in Duza.

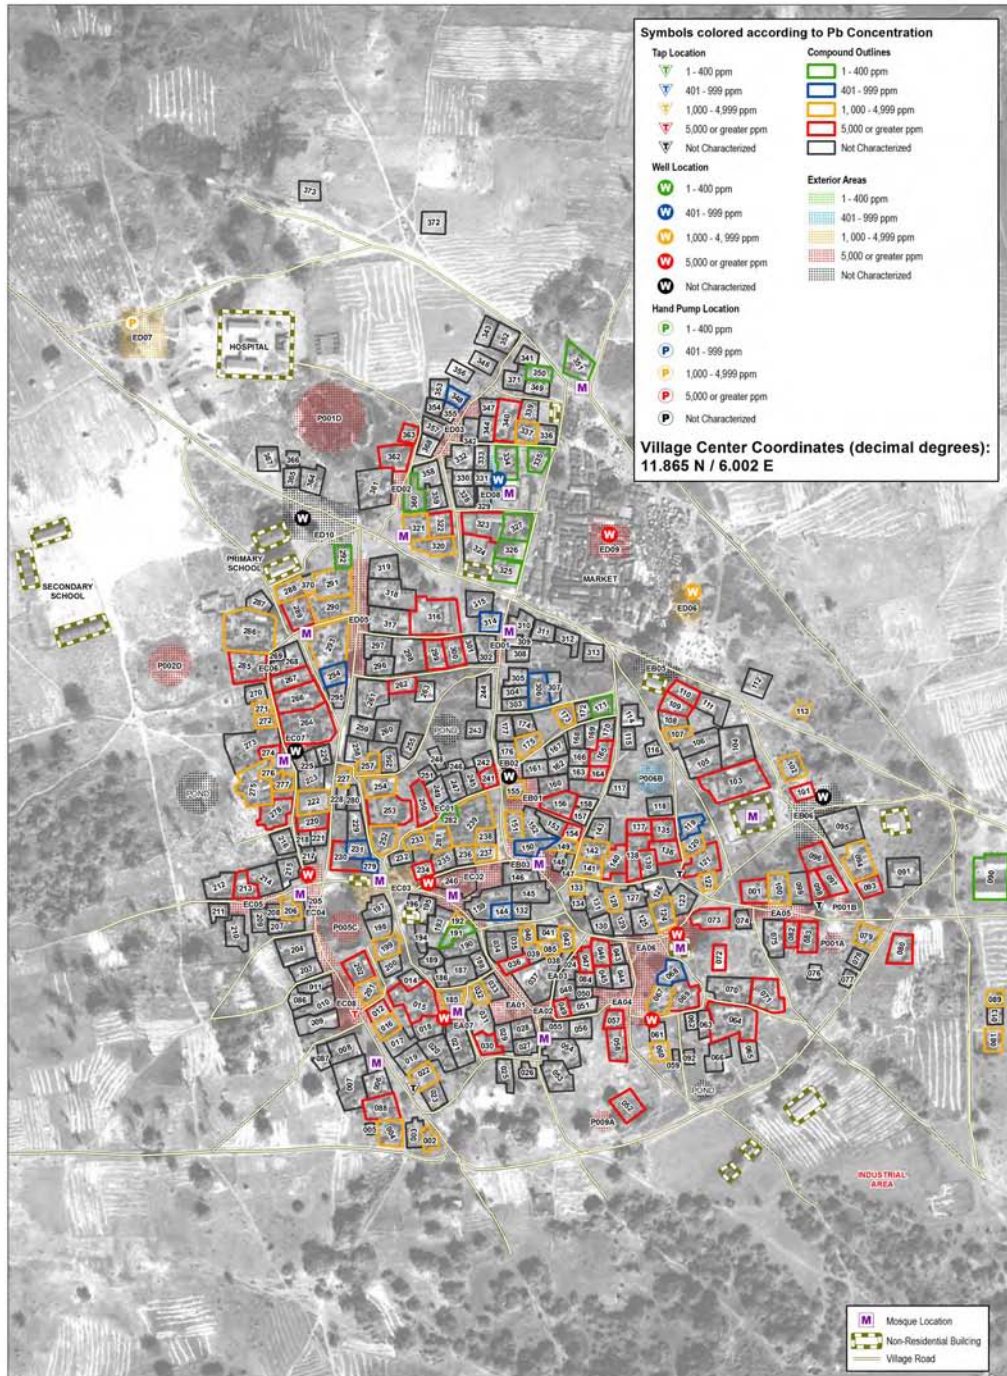
Figure 8. Current contamination levels in compounds and public areas in Bagega.

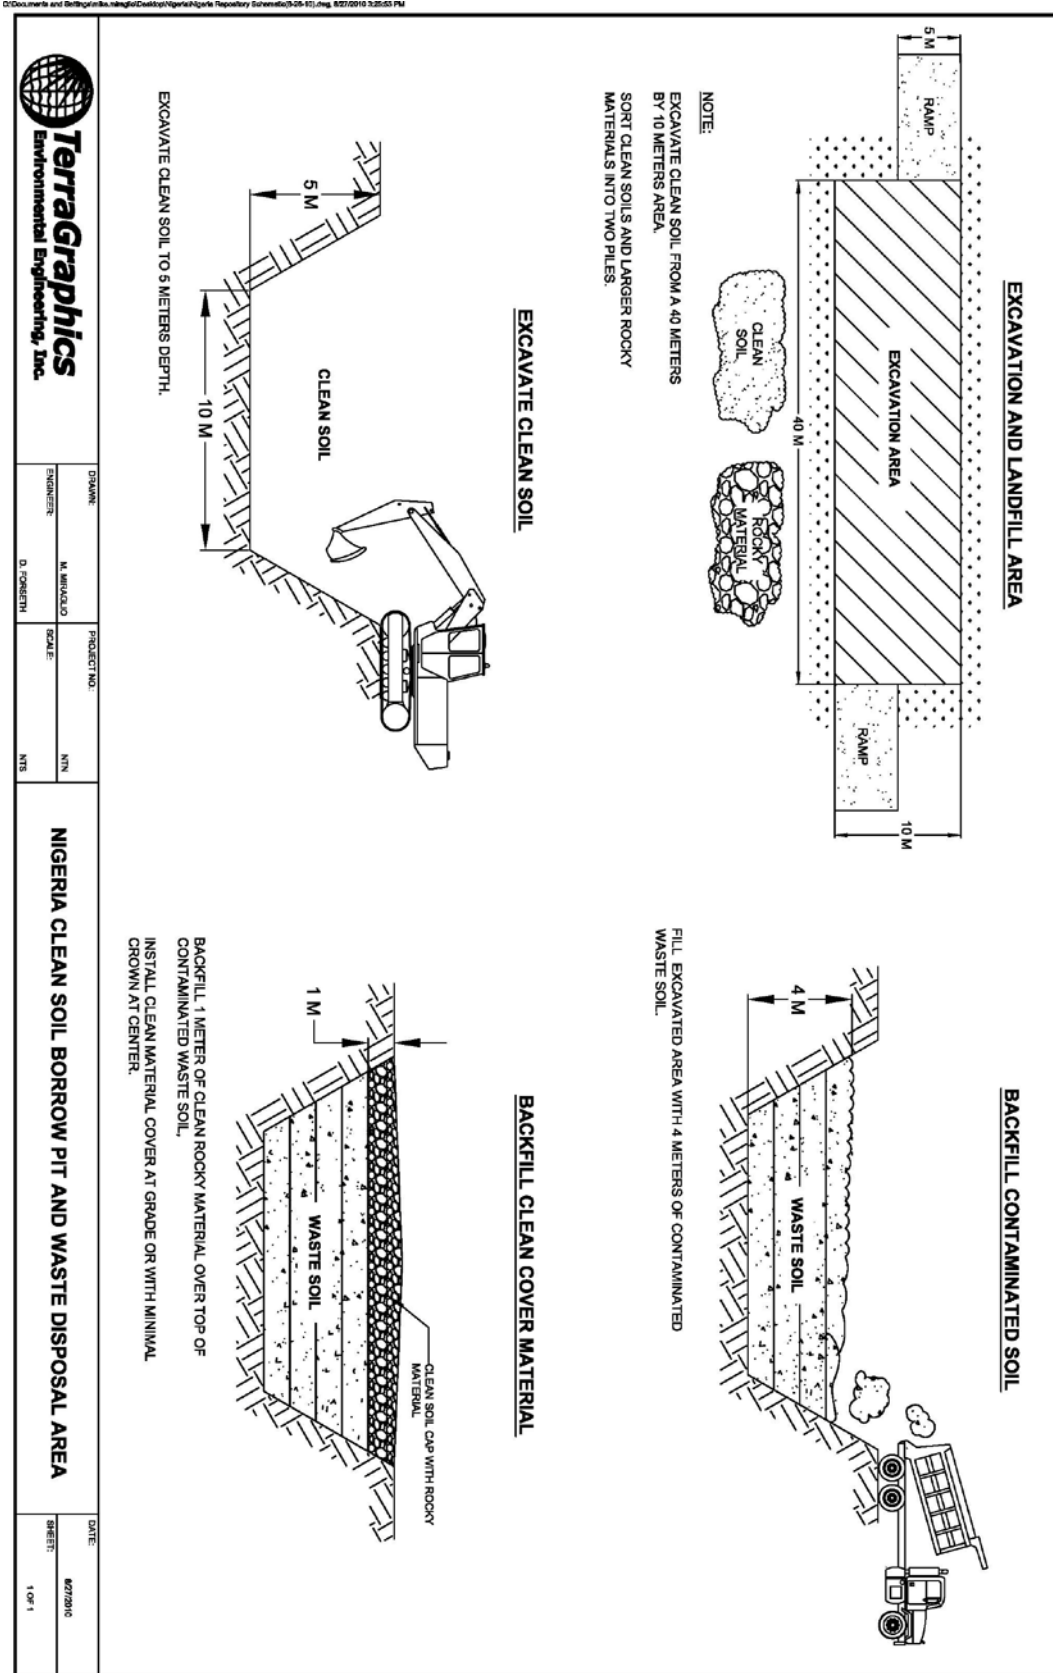
NIGERIA CLEAN SOIL BORROW PIT AND WASTE DISPOSAL AREA

Clean soil shall be excavated and stockpiled at the source location by the excavator and payloader. One to one and one half the expected need should be excavated to ensure sufficient quantities are available after the excavator leaves the site. Soils shall be transported from the storage area to the village in tipper trucks in 5-10 cubic meter loads and dropped in strategic locations within each village. The Clean Soil Manager shall develop a staging plan in consultation with the Village Cleanup Director and RPR. The Clean Soil Manager shall direct the staging of tipper loads. Material may also be placed by the payloader. Extreme care must be exercised to avoid any damage to structures and endangerment of villagers during this operation. The streets are narrow, uneven, poorly maintained and unaccustomed to heavy vehicles. Traffic control is difficult and many villagers including children are usually present.

The staging locations should be convenient to the compounds and outside areas requiring remediation, avoid contaminated locations, not block village traffic, or surface and waste water drainages. Permission from neighbors to drop soils should be obtained whenever possible. Soils will be removed from the local staging areas by wheelbarrow.
